Date: Sun, 01 Sep 2002 20:44:21 -0700 From: Bill Marvel <bmarvel@cox.net> To: rv-list@matronics.com Subject: RV-List: [SoCAL-RVlist] Riveted joint test results Sender: owner-rv-list-server@matronics.com Reply-To: rv-list@matronics.com

Two days ago I got around to doing something that I had planned last year -- actual pull tests on riveted aluminum coupons to see how critical it is to drive rivets to the correct height. All of us building or with completed RVs (as will those those planning on it in the future) have had to wonder which imperfect rivets to drill out and which are OK. The answer is obvious when there is a severe cosmetic problem, but when strength is at issue, how much does a slightly under or overdriven rivet affect strength? How much does a grossly under or overdriven rivet affect it? Frankly, I had made the decision that the risk of damage from drilling out a flush rivet is greater than the benefit of doing so, unless an obvious cosmetic defect or really bad rivet is at issue. Now I have some hard data to go by.

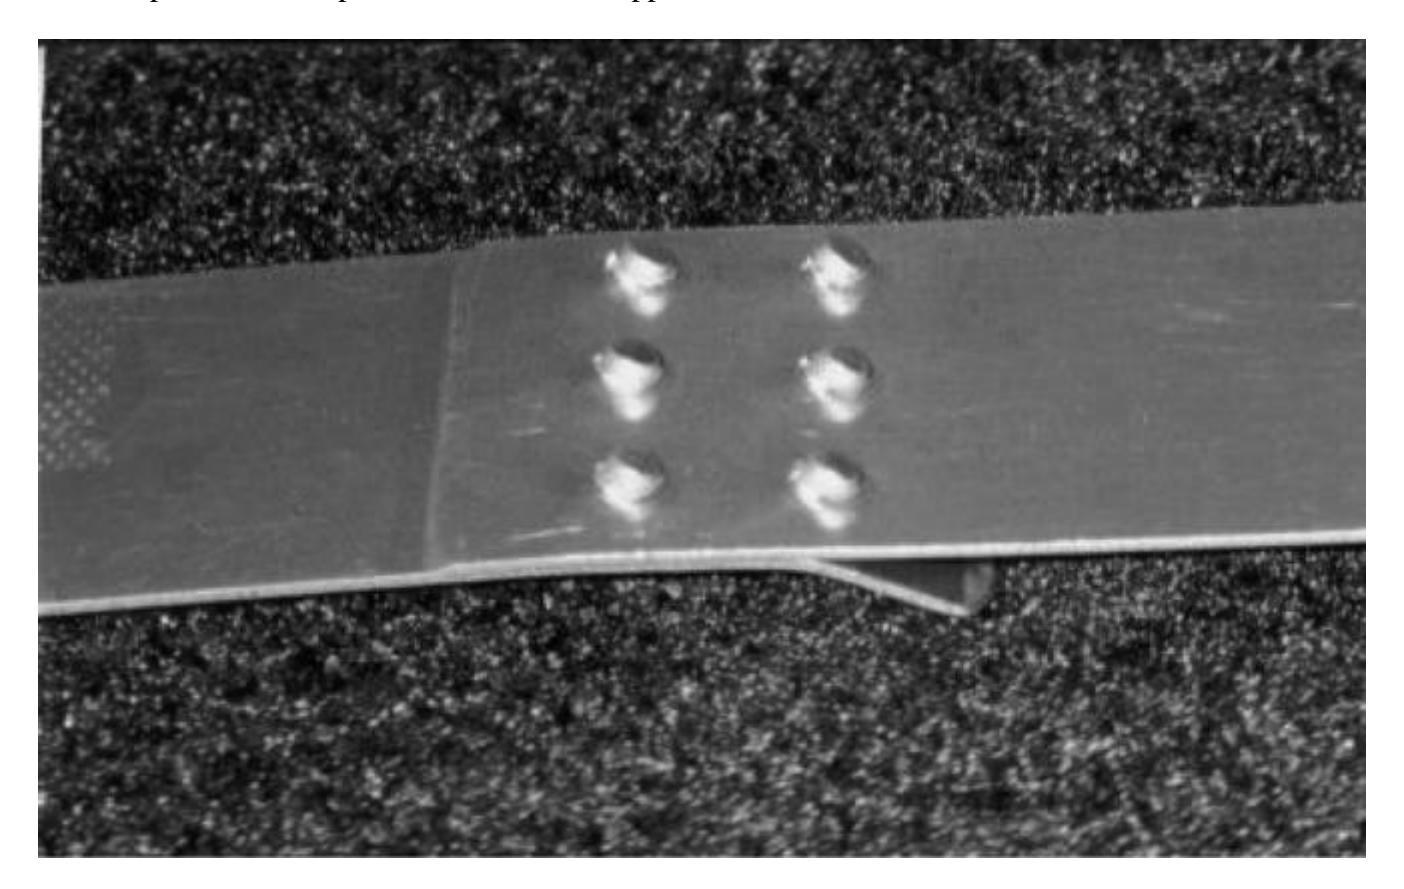
- 1. The dimpled, flush riveted construction was stronger, but not by as much as I had thought. However, and this is really important, initial failure of the dimpled construction was generally not catastrophic and occurred as rivet tipping and rivet head distortion. In contrast, initial failure of the AN 470 undimpled construction was generally catastrophic by rivet shear. I am really happy Van uses the flush riveted, double dimpled joints throughout most of the airplane!

This view of the shop head side depicts the "rivet tipping" failure mode that appeared in all of the coupons riveted with AN426 rivets. The raised edge of one coupon occurred during the test and was a typical part of the failure.

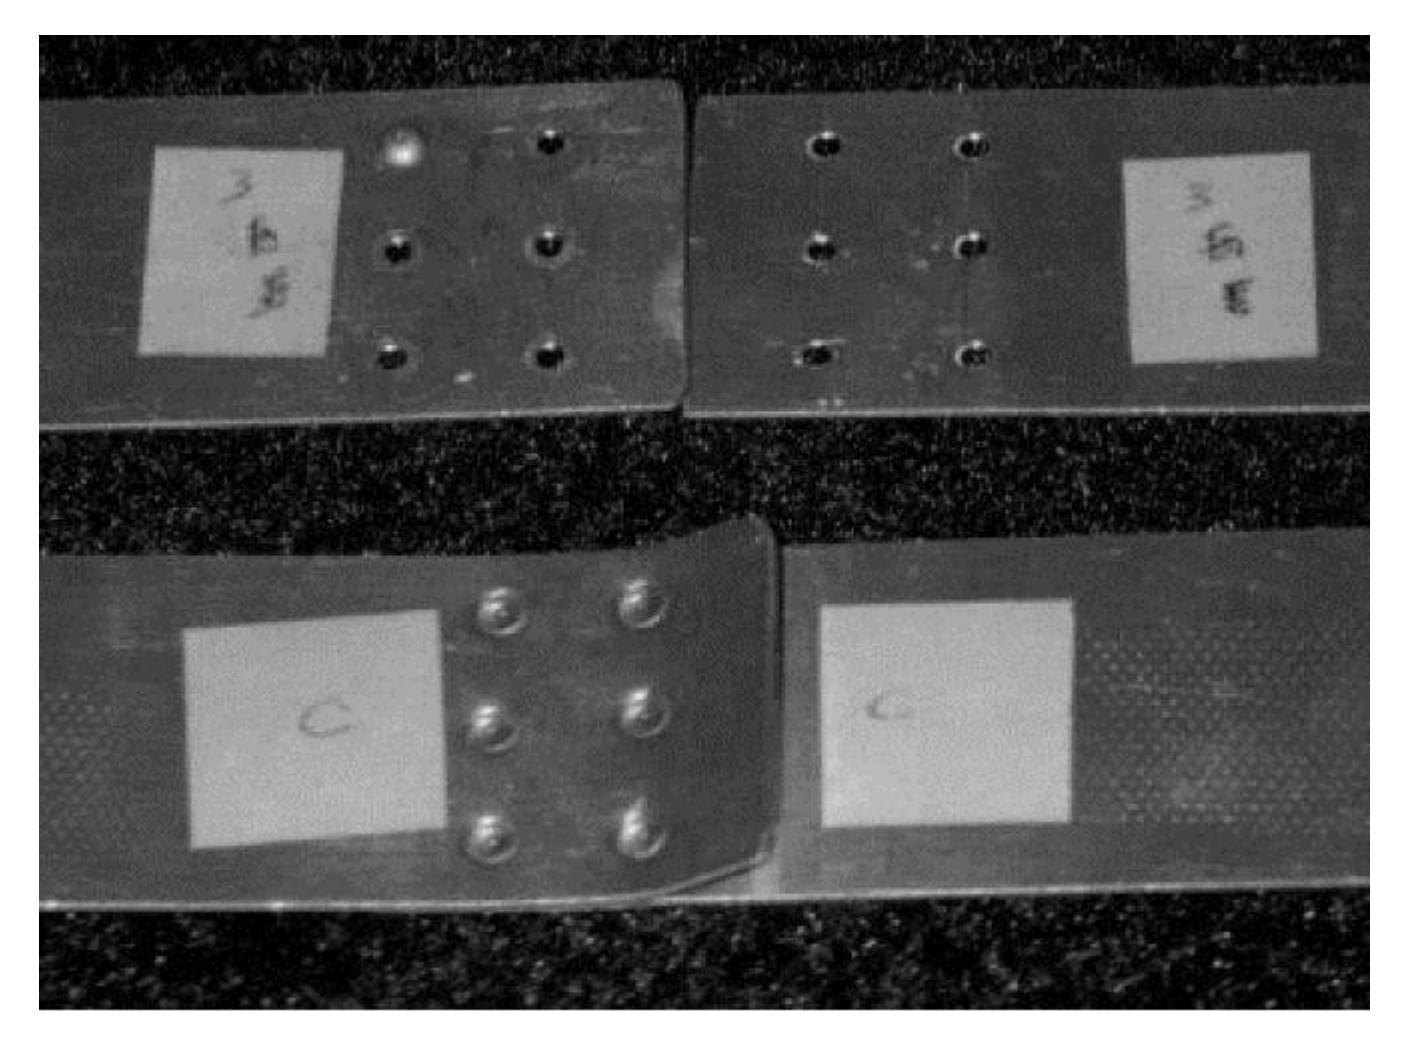
This view shows the coupons with properly set rivets in their failed state. Most notable is the fact that the top coupon, riveted with universal head rivets, failed catastrophically with all six rivets sheared. Only one rivet head remained in place; the rest all popped out on failure. Note how little deformation exists in the rivet holes in the parent material. In contrast, the lower coupon, double dimpled and riveted with flush rivets, is still intact. It shows deformed manufactured heads on top, and the tipped rivet pattern on the bottom as shown in the prior photo.

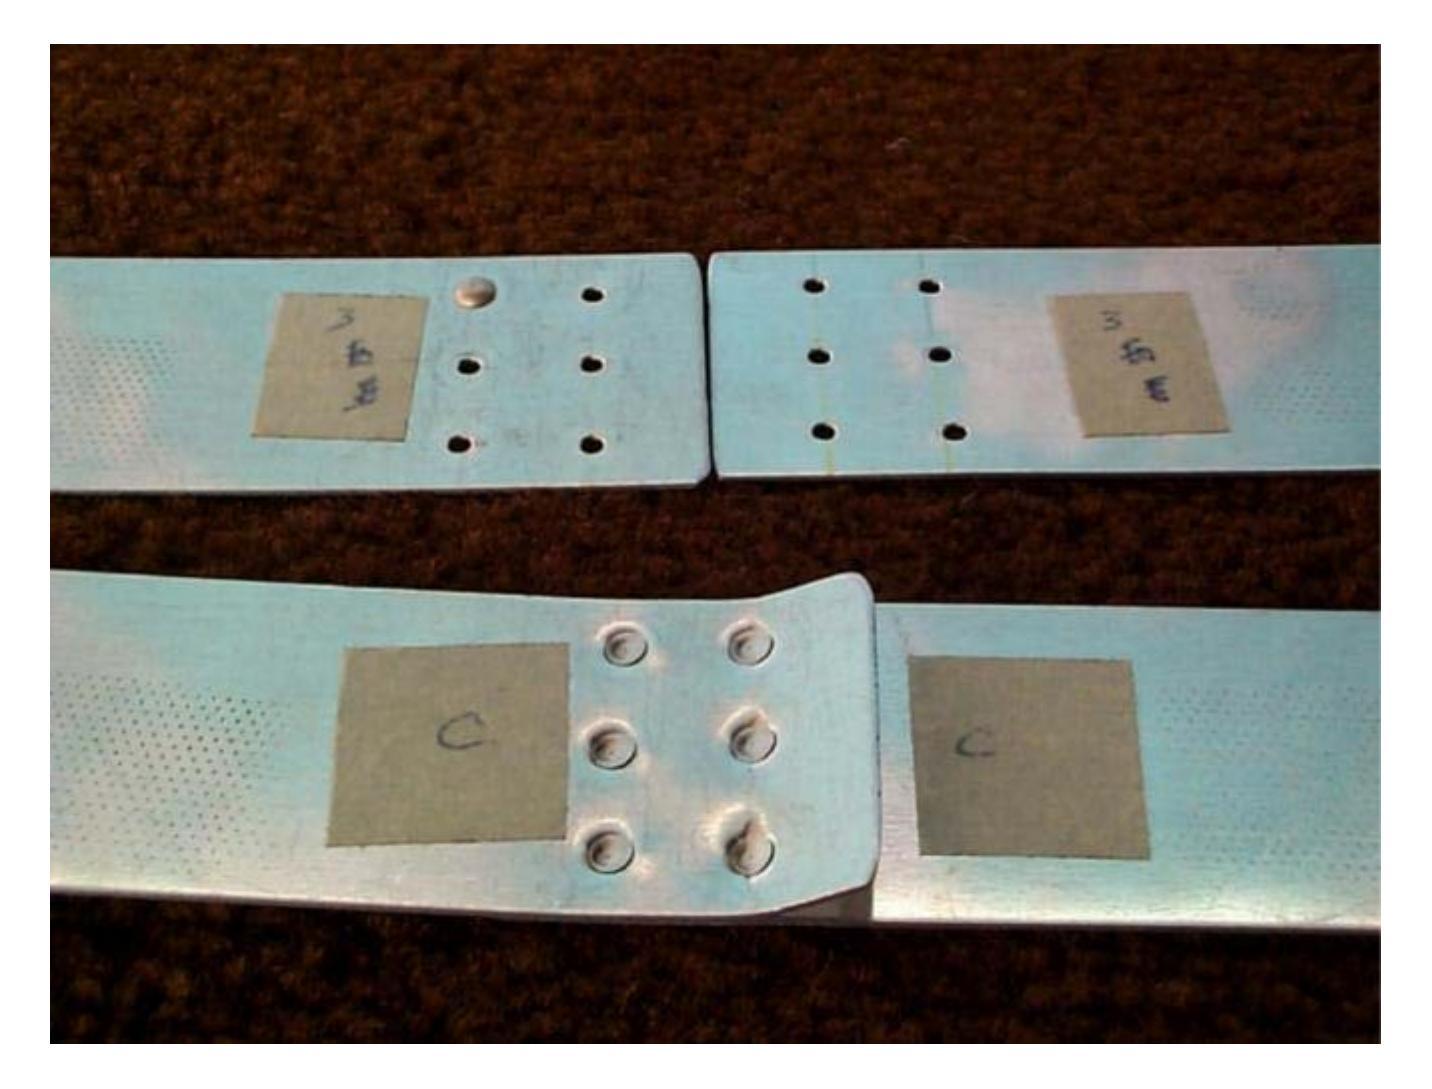
AN 470 AD 3 Table			
Condition	Force at failure	Nature of failure	
Gross under	1100	Rivet tip plus one sheared rivet	
Slight under	1600	5 sheared rivets!	
Correct	1625	6 sheared rivets!	
Slight over	1750	6 sheared rivets!	
Gross over	1500	Rivet tip plus sheet tear at rivet line

A closer view of the photo above, showing more detail of the deformation of the holes and rivet heads. As you view this, keep in mind that the failure of the top coupon with AN 470 rivets occurred at 1625 pounds of force and was catastrophic with all six rivets shearing simultaneously. In contrast, failure of the lower coupon was by deformation only at a force of 2026 pounds. The interlocking, dimpled joint is 25% stronger and when it fails, does not fail catastrophically. Which would you rather have on your wing skin as you start pulling more Gs?
