Date: Sun, 01 Sep 2002 20:44:21 -0700 From: Bill Marvel <bmarvel@cox.net> To: rv-list@matronics.com Subject: RV-List: [SoCAL-RVlist] Riveted joint test results Sender: owner-rv-list-server@matronics.com Reply-To: rv-list@matronics.com

Two days ago I got around to doing something that I had planned last year -- actual pull tests on riveted aluminum coupons to see how critical it is to drive rivets to the correct height. All of us building or with completed RVs (as will those those planning on it in the future) have had to wonder which imperfect rivets to drill out and which are OK. The answer is obvious when there is a severe cosmetic problem, but when strength is at issue, how much does a slightly under or overdriven rivet affect strength? How much does a grossly under or overdriven rivet affect it? Frankly, I had made the decision that the risk of damage from drilling out a flush rivet is greater than the benefit of doing so, unless an obvious cosmetic defect or really bad rivet is at issue. Now I have some hard data to go by.

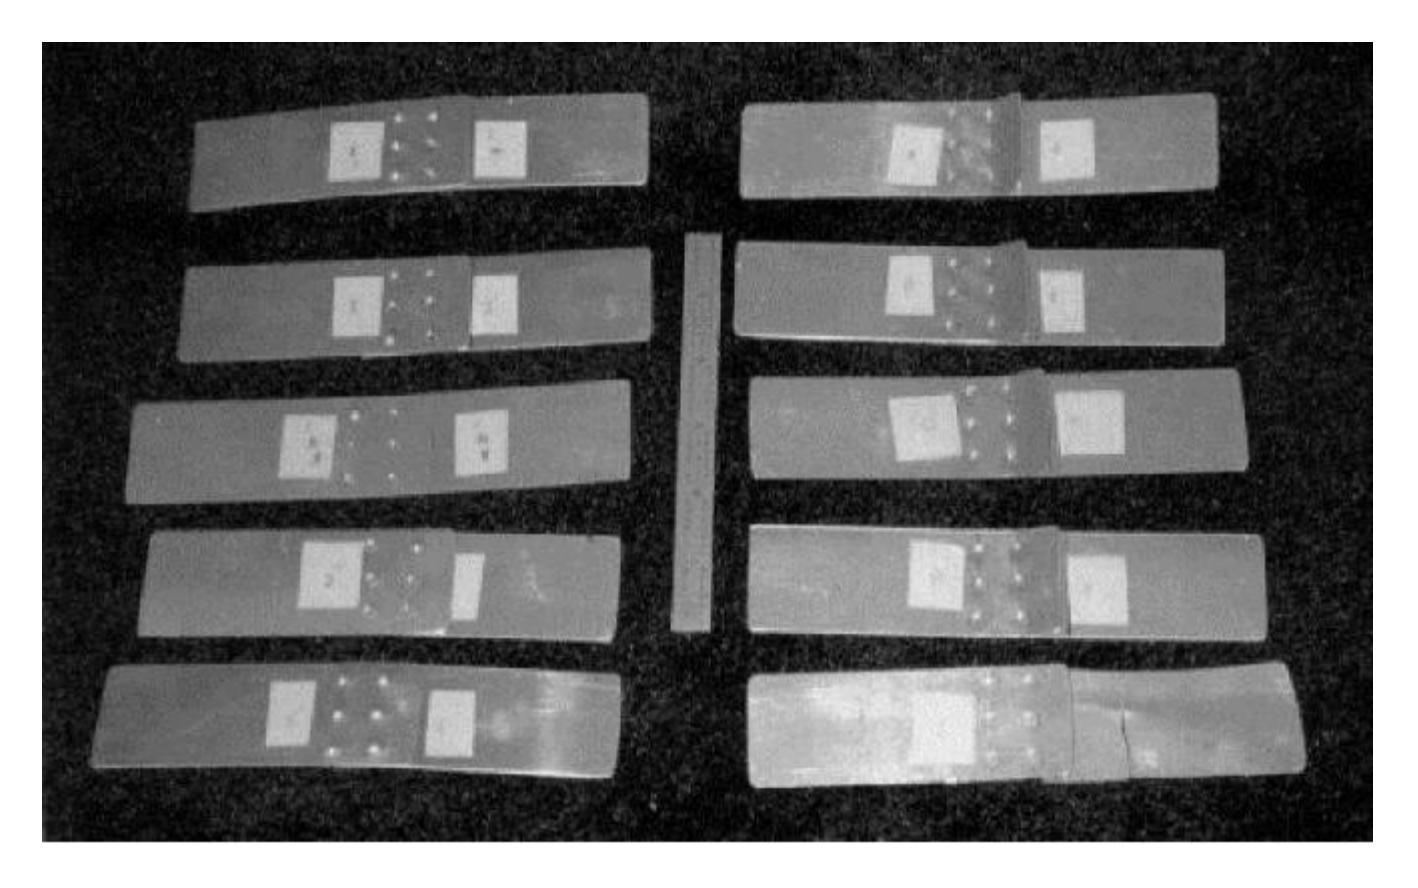
Shown above are the 10 coupons used in the test. On the left side are those riveted with AN470AD3 universal head rivets and on the right are those riveted with AN426AD3 flush rivets. In the latter case, both coupons were dimpled. A six inch ruler appears in the center to show relative size.
